# AIR FORCE MISSILE DEVELOPMENT CENTER TECHNICAL REPORT

MANHIGH 1

MANHIGH I

→ Operation ~~MANHIGH~~ <sup>1-10</sup> I was the first of a series of manned balloon probes into the upper atmosphere, as a preliminary investigation to the Man in Space program. The structure and instrumentation of the capsule and aerostat are described, and the collected data are plotted and analyzed. +

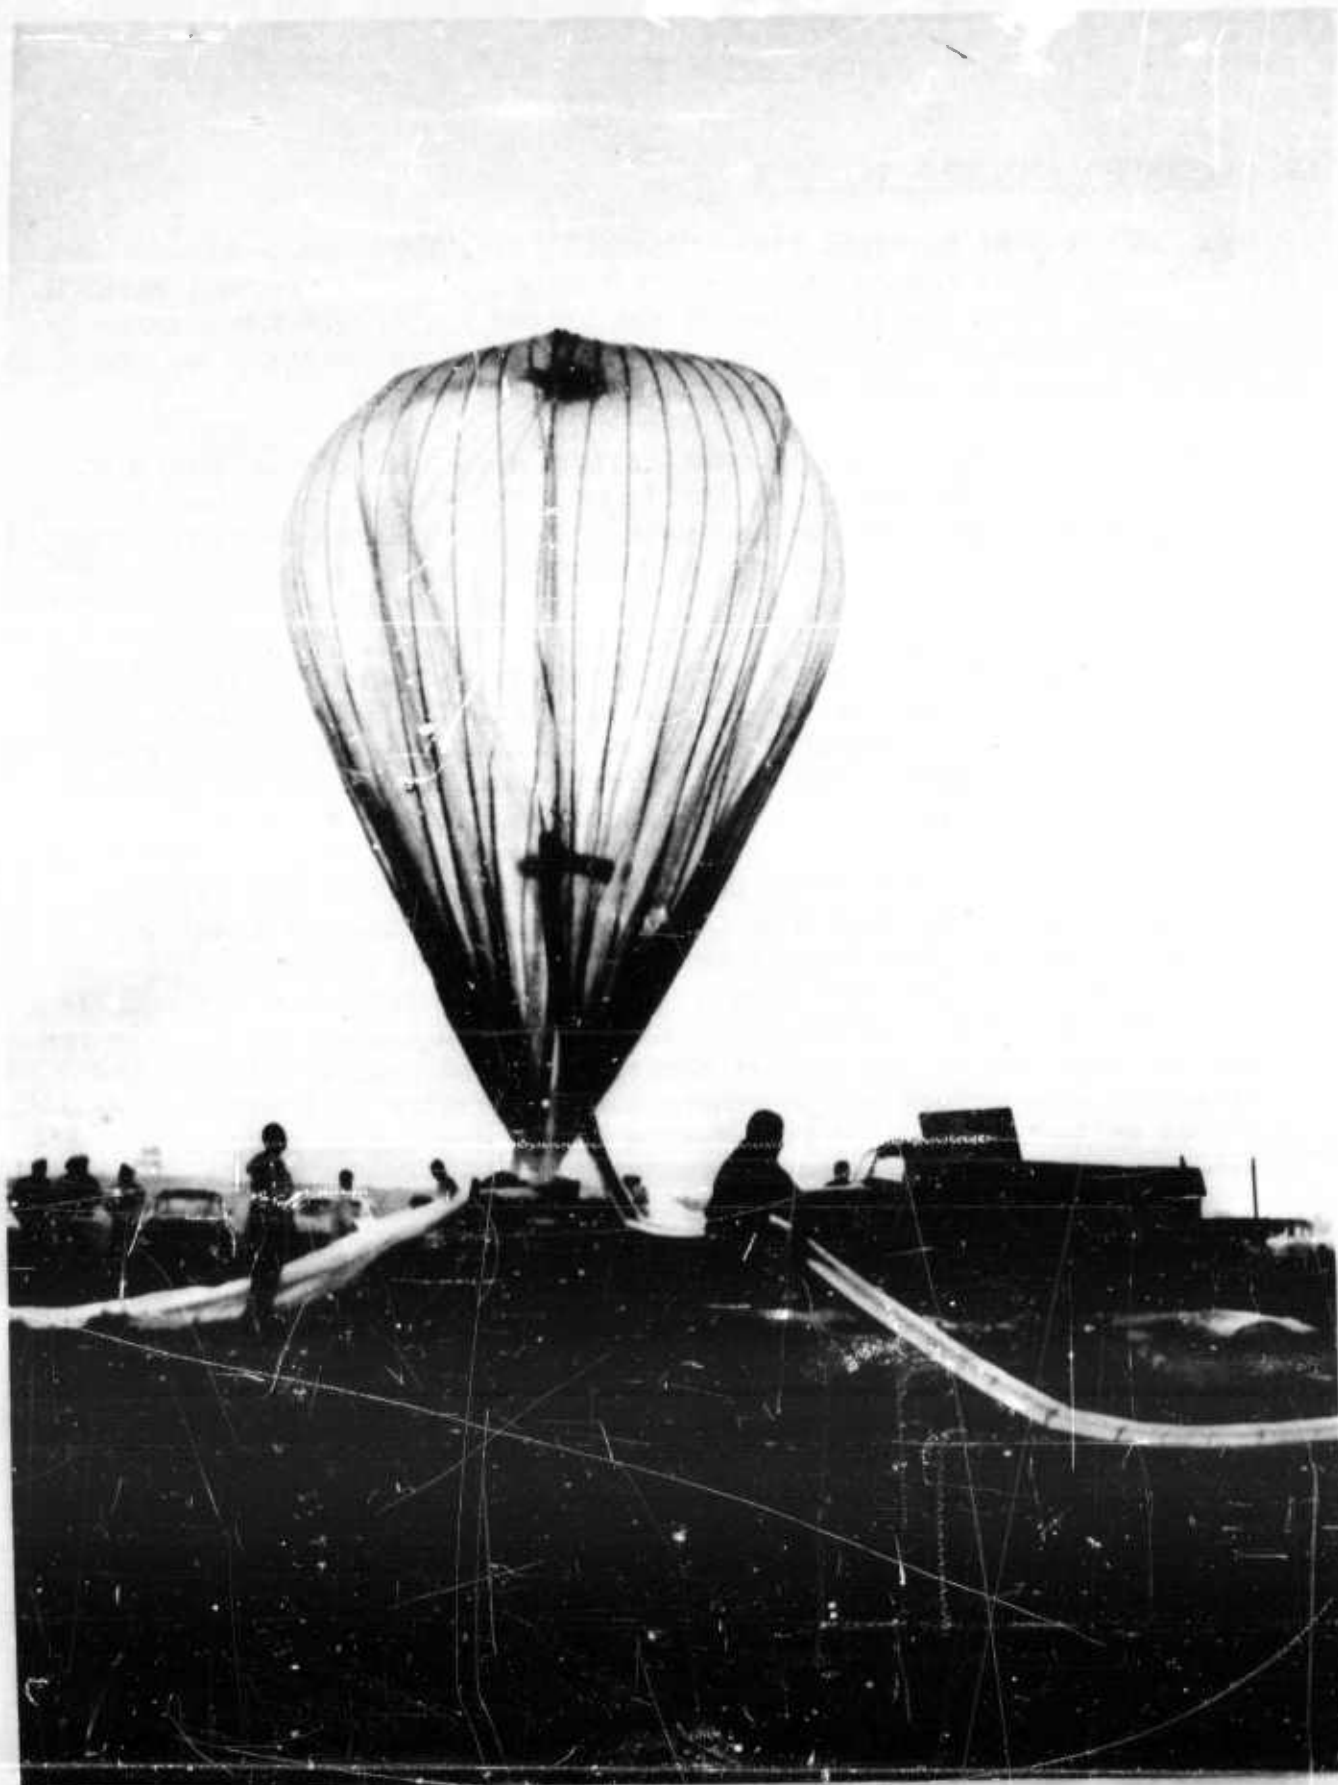
FIGURE 1

The pre-launch activities proceeded according to plan. The balloon was inflated and all flight equipment was installed. (See fig. 1).

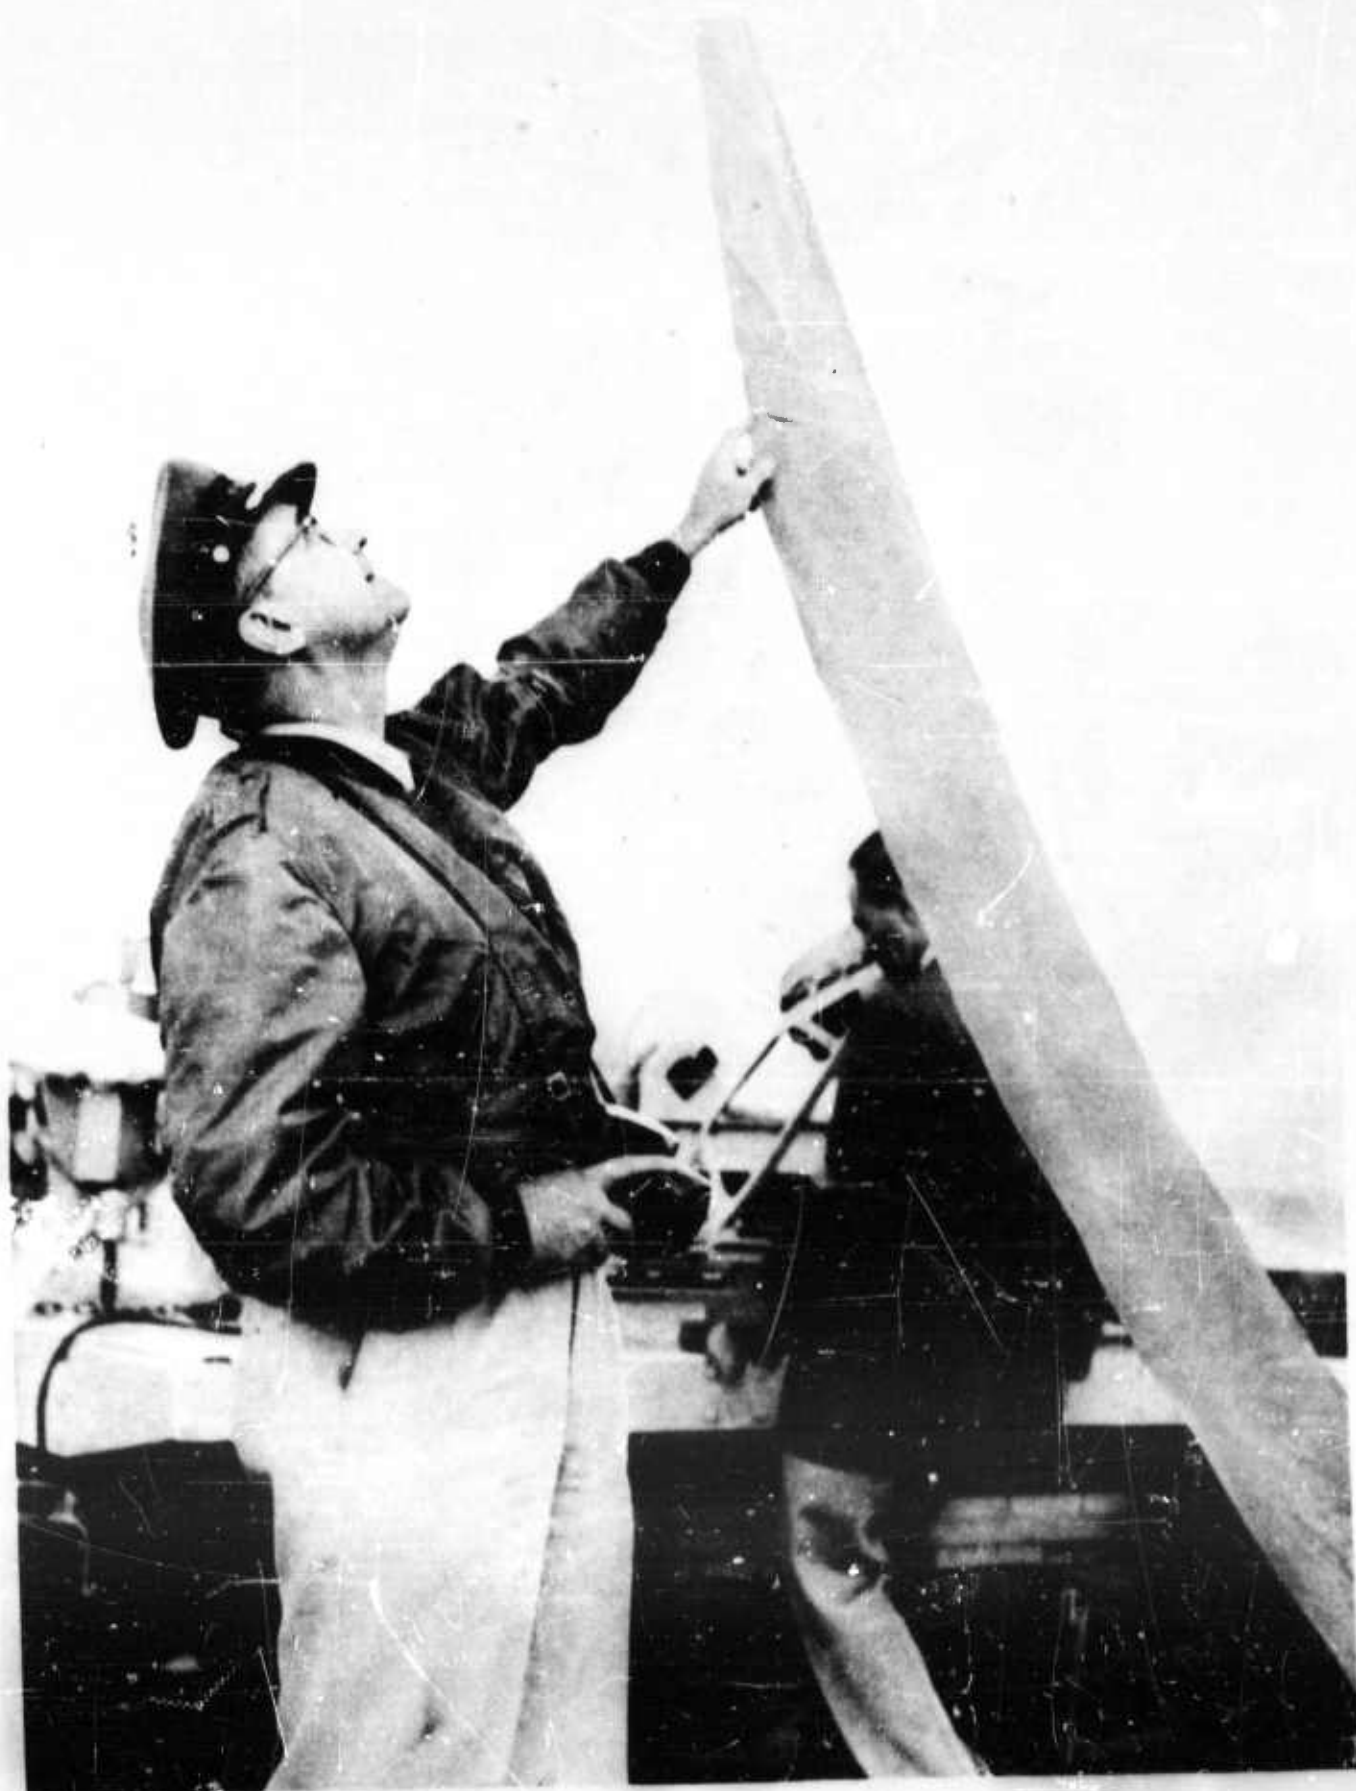
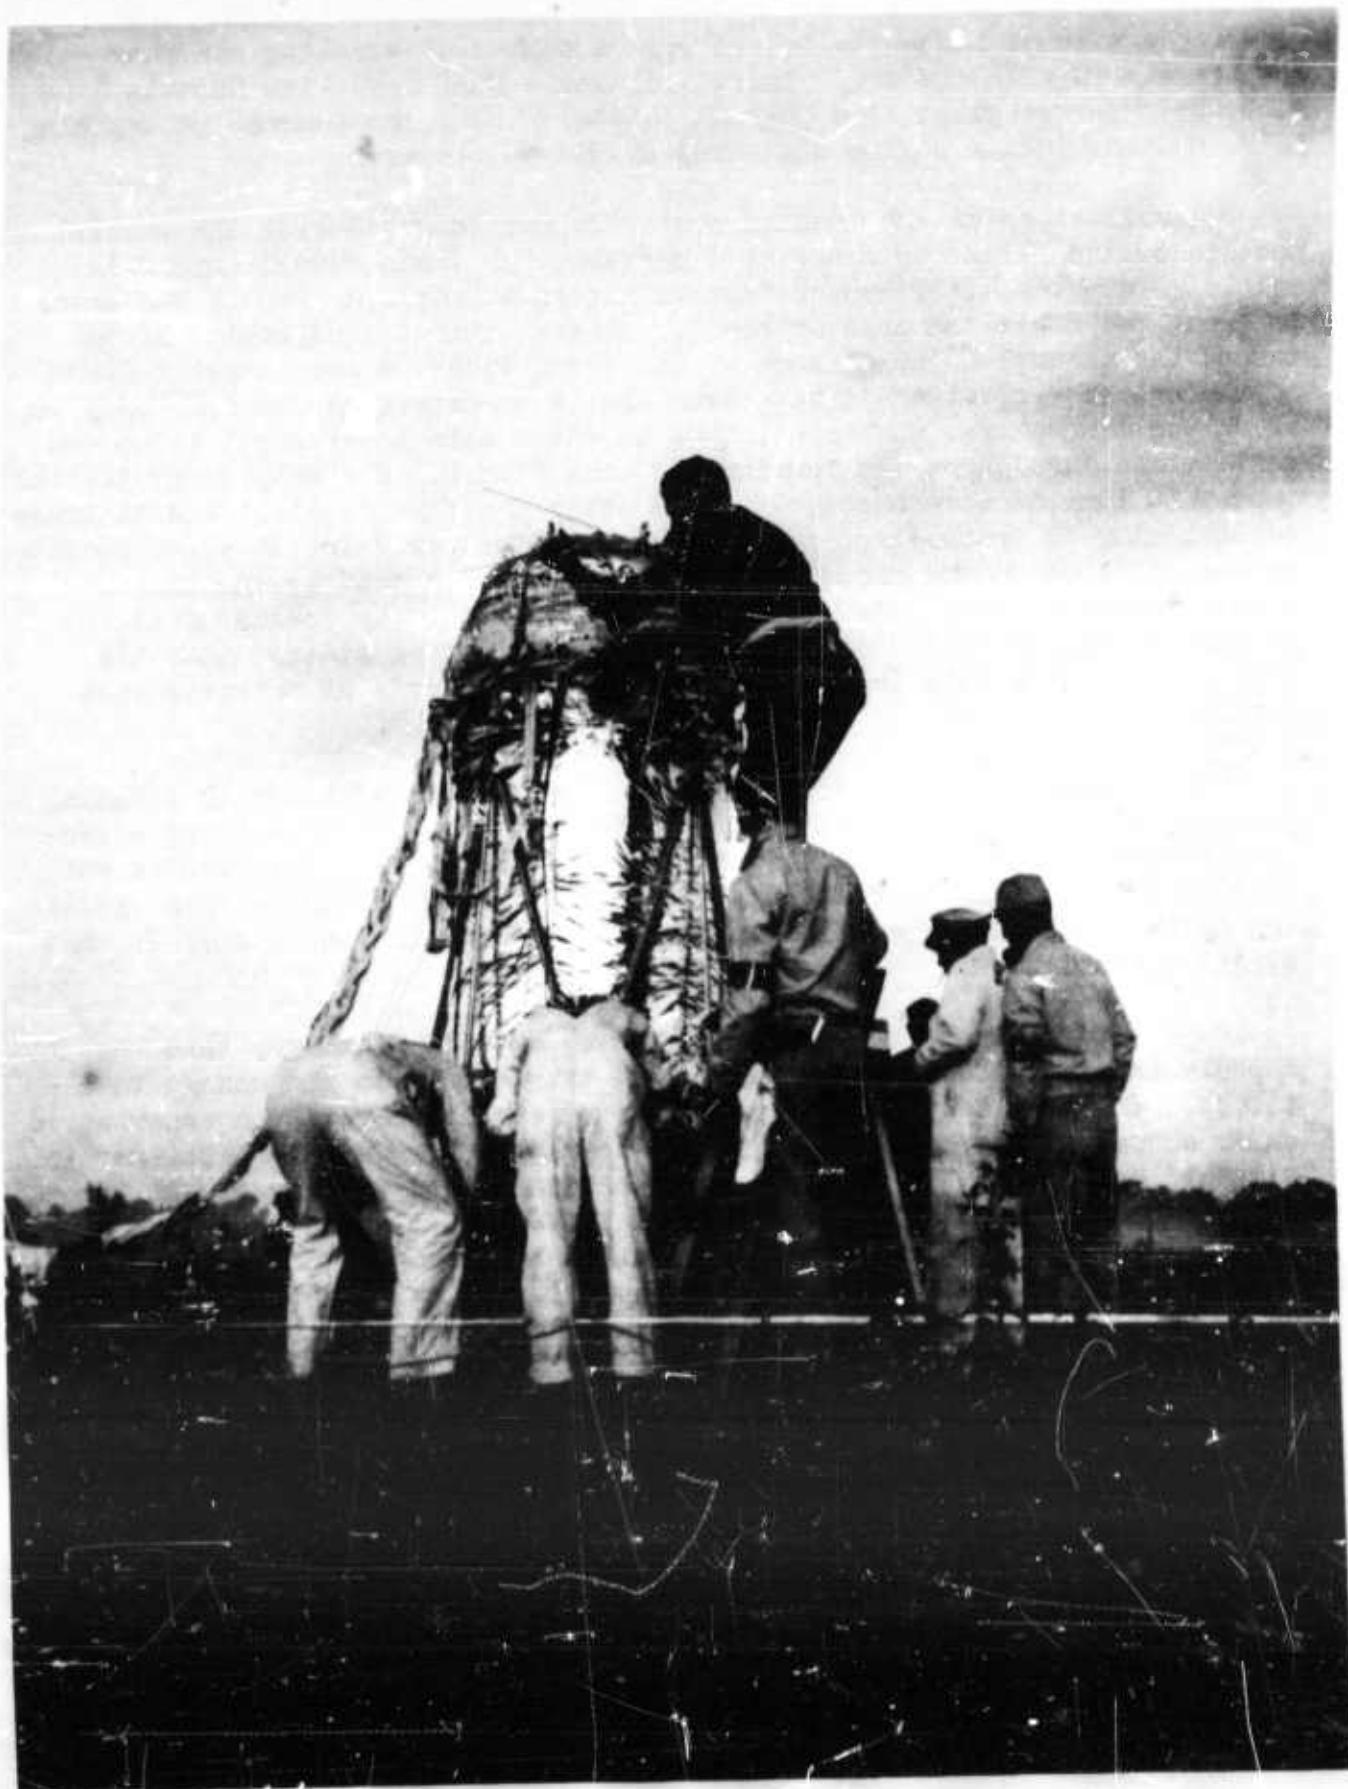
At 0620 CDT all preparations were complete, the surface winds were peaking at approximately two knots, and synoptic meteorological conditions were ideal for the anticipated flight. At 0623 CDT the balloon was released from the restraining rollers of the launching platform, and as the balloon ascended slowly, the capsule was lifted into the air (fig. 2, 3, and 4).

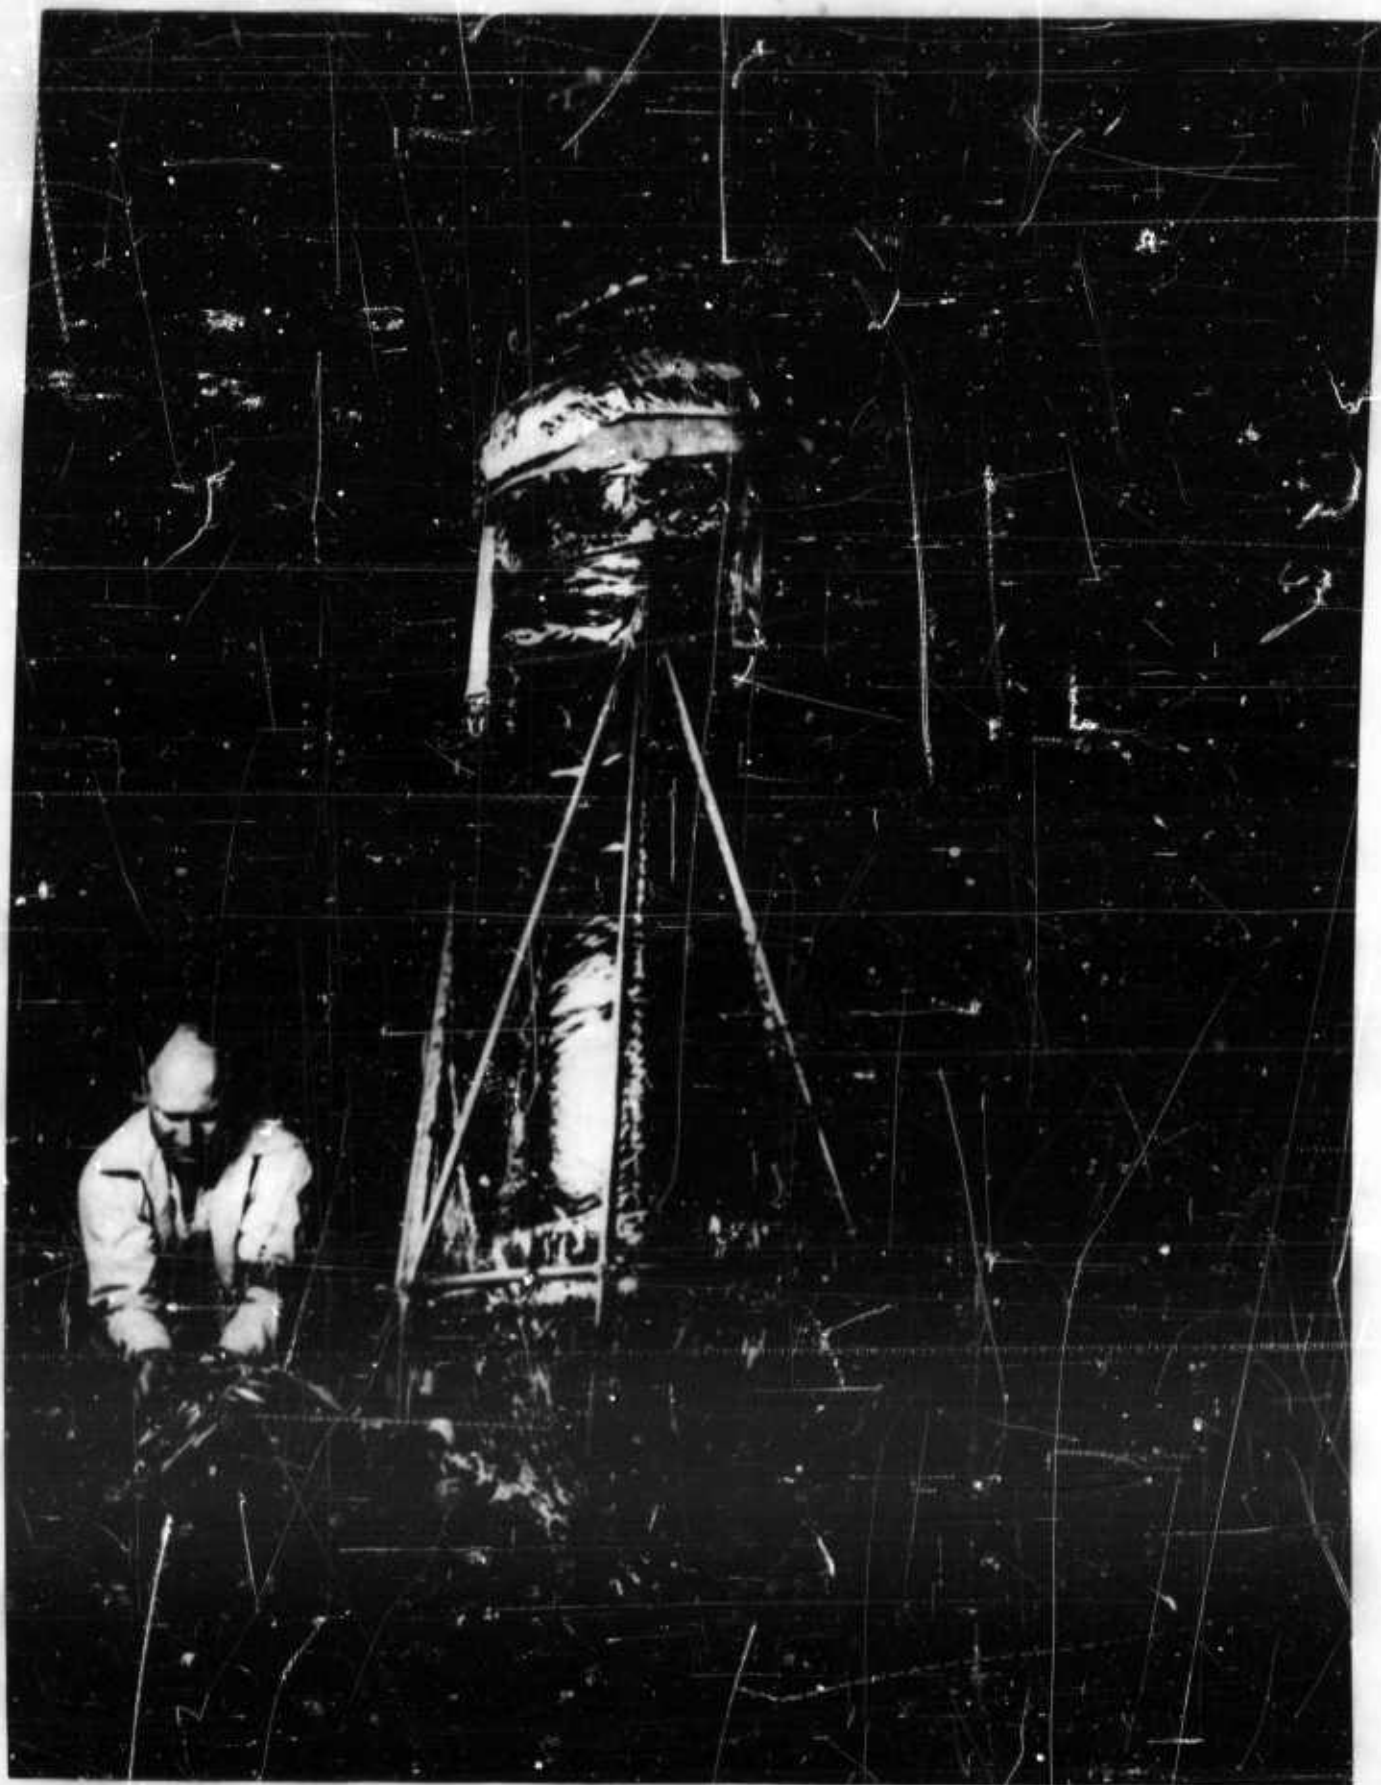
FIGURE 10

The sealed atmosphere in the capsule was chemically treated to remove carbon dioxide and moisture, and an external water evaporation-type cooling system was used to maintain the capsule temperature at a comfortable level (fig. 10)

The capsule cooling was accomplished by circulating the capsule air through a finned-tube water-core heat exchanger. The heat exchanger was located externally and designed to remove approximately 1600 BTU/hr in the normal temperature range. No provisions were made for heating the capsule because the heat input from the pilot, air regeneration system, electrical components, and solar radiation would more than compensate for the heat loss from the capsule.

The air was circulated, by a 200 cfm axial-type blower, from the base of the capsule through the cooling core and returned to the upper section of the capsule. A water trap was located such that it collected condensation that formed on the cooling core.

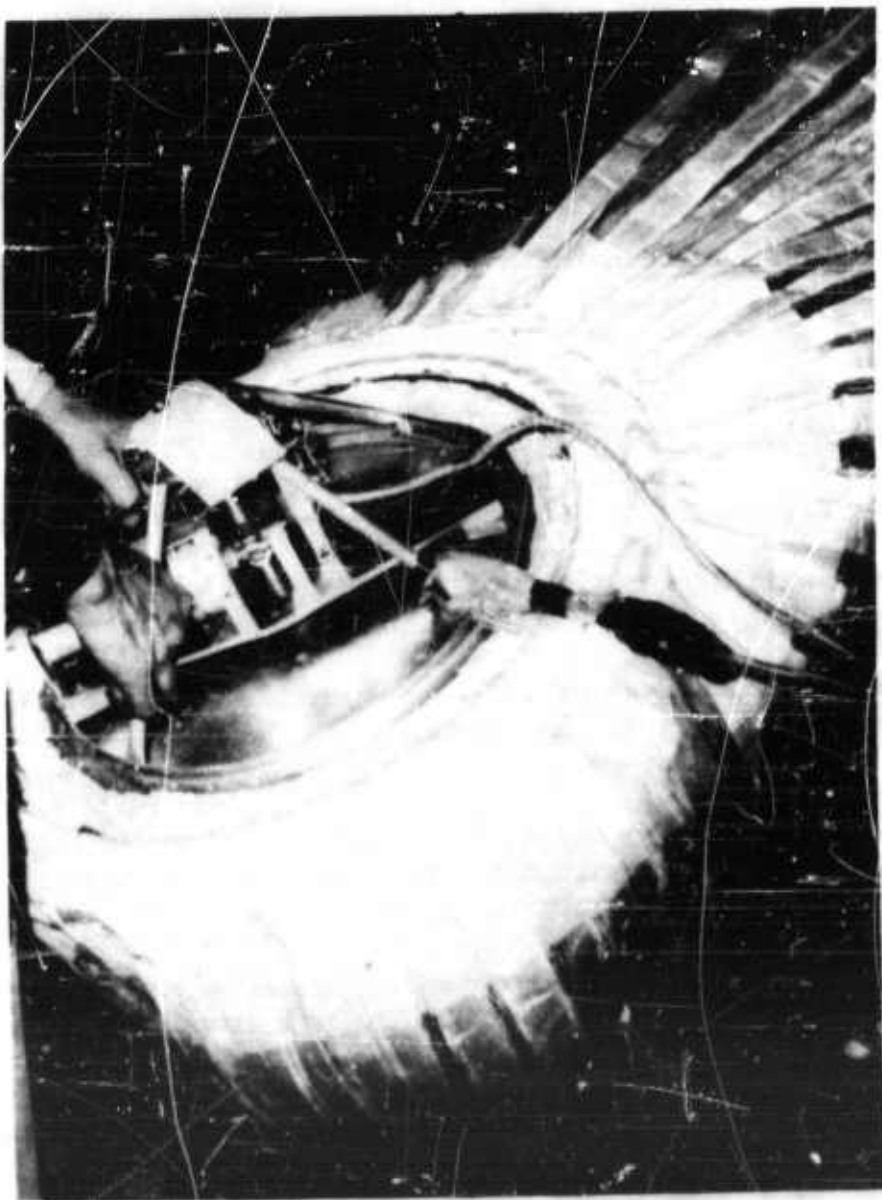
FIGURE 12

Installed at the apex of the balloon was an electrically driven 14-inch diameter fail-safe gas valve. (See fig. 12.) This valve was controlled from the electrical panel inside the capsule. The actuation of this valve permitted Captain Kittinger to release the helium gas from the balloon in order to decrease the rate of ascent, initiate descent, or to increase the rate of descent.
